## Home Inspection Report

**683 West Shore Boulevard  
Pickering, ON L1W 3G2**

**Date of Inspection: 02/17/2025**

Inspection No. 914902-816

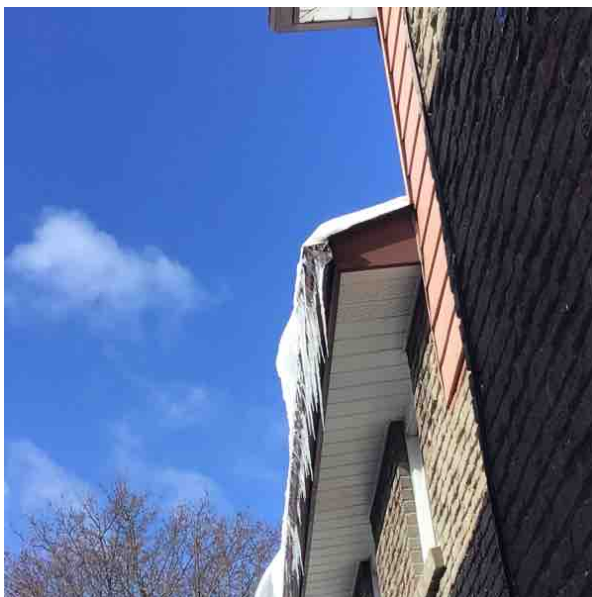
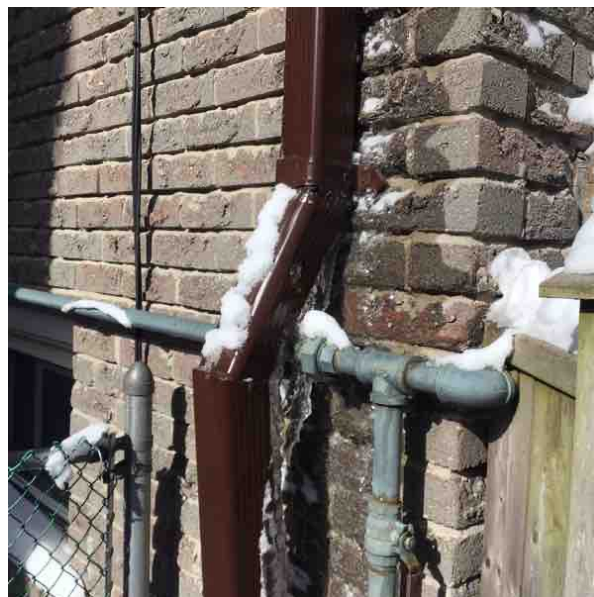
3.3.1 Icicles are a safety concern and ice damming can cause water to damage sheathing and roof structure. As a proactive step consider the Installation of larger gutters, improving ventilation in attic space, installing heating coils and keeping gutters clean and free of debris as this will encourage proper drainage off roof and help prevent ice build up. Cleaning gutters and downspouts is an ongoing maintenance requirement that should be completed twice a year or as required to ensure proper drainage away from wall surface and foundation.

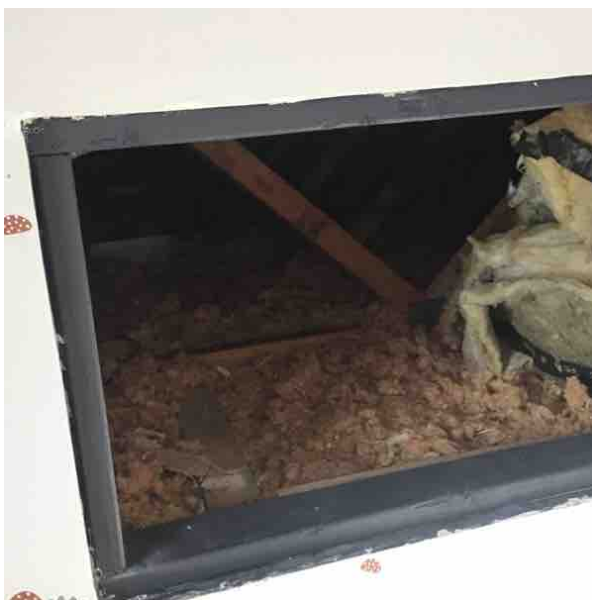
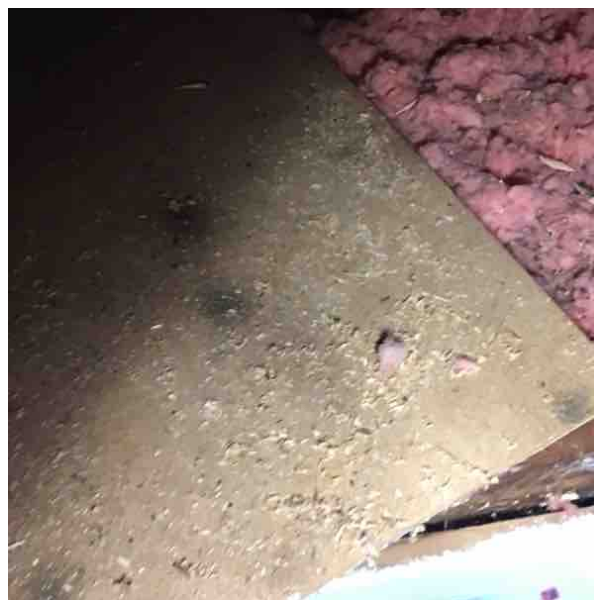
4.1.1 Recommend insulating and weather stripping attic hatches to prevent warm moist air from entering attic space and causing moisture related damage.

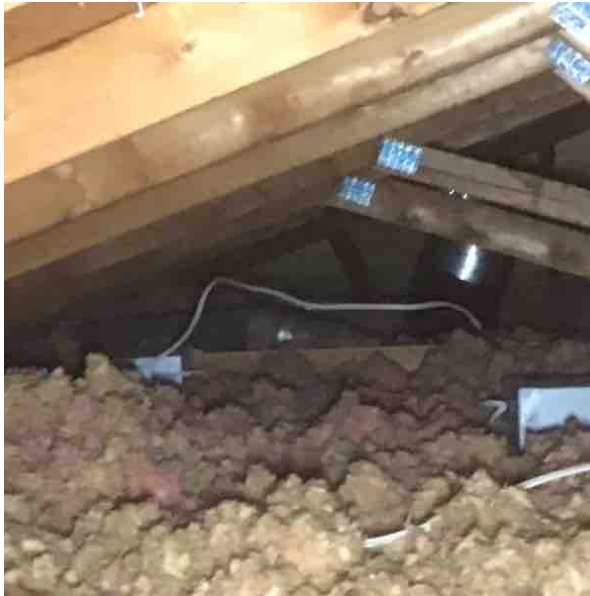
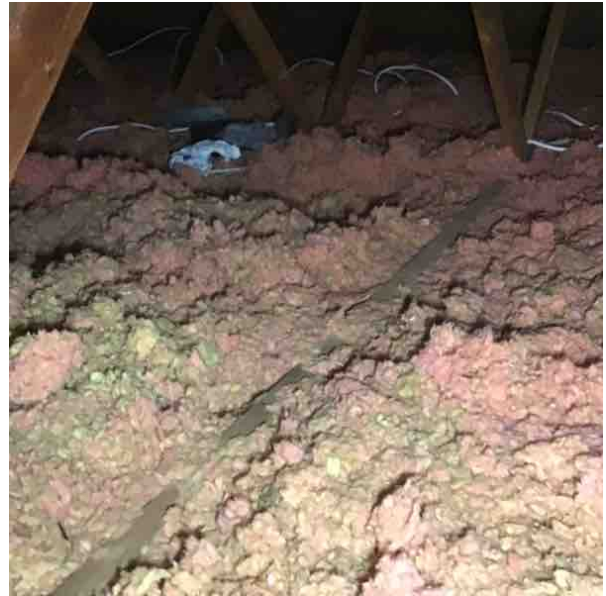
4.2.1 The insulation in the attic is compressed / uneven. Provide additional insulation or redistribute in the low areas to prevent excessive heat loss / gain and improve energy efficiency.

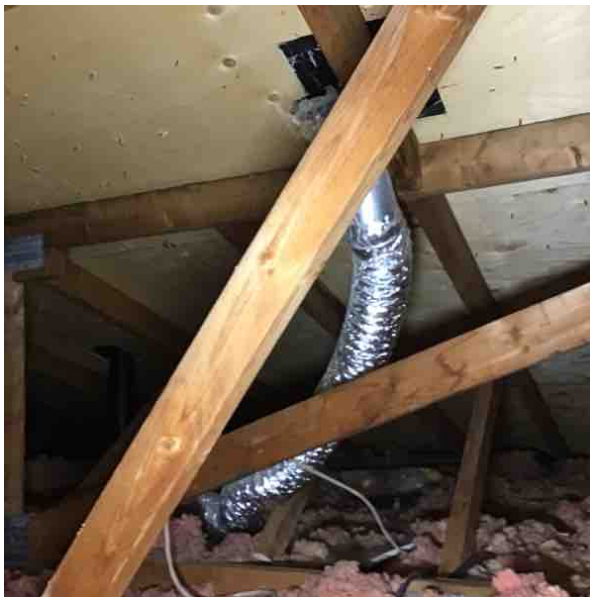
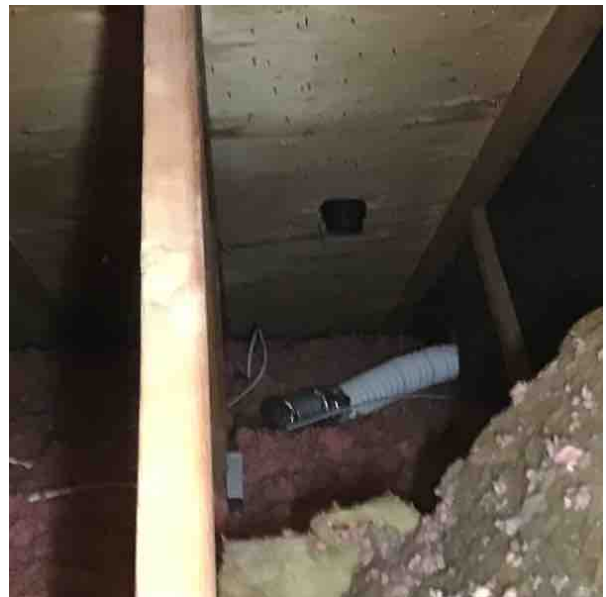
4.4.1 The exhaust duct is not insulated (both attics), disconnected / improperly sloped. Correct the installation to include an insulated pipe and ensure a consistent upward slope to prevent condensation build-up and subsequent water related damage to attic components.

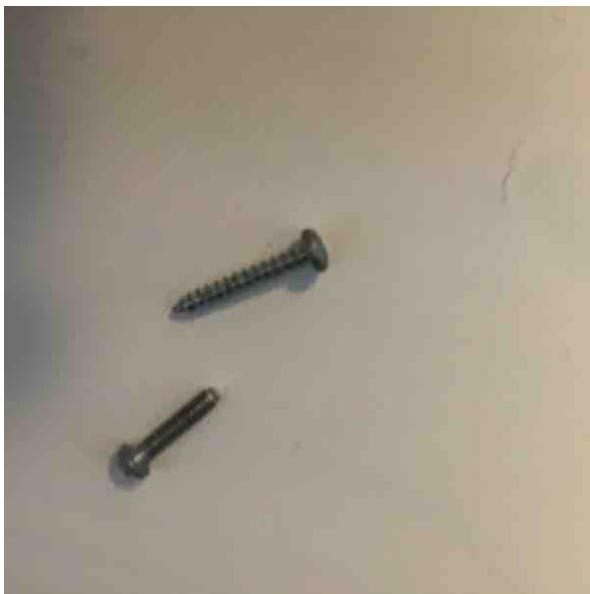
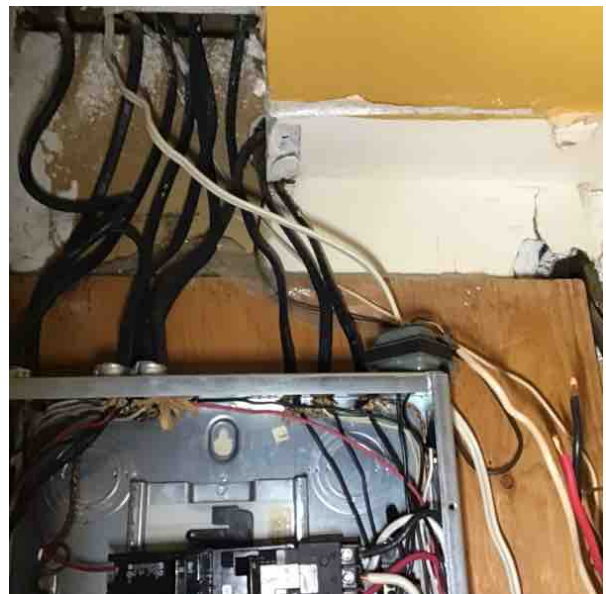
7.3.2 The distribution panel has loose wiring in vicinity of panel and improper pointed panel screws - correct as required for electrical safety.

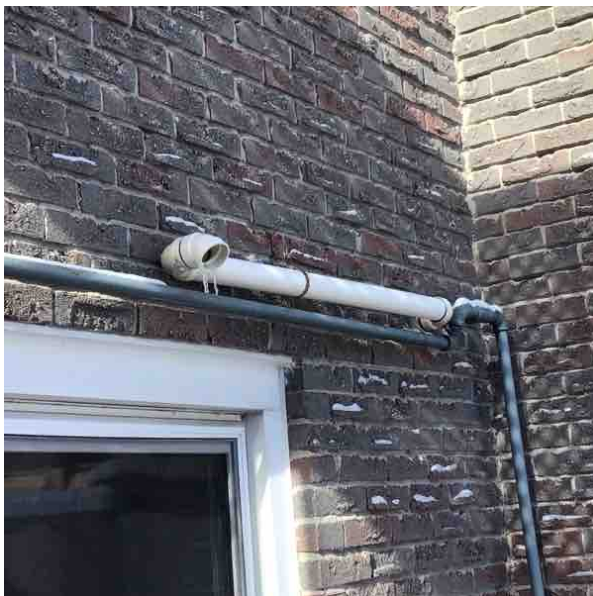
8.5.1 Exhaust pipe is too close to window and should be insulated - correct installation for proper / safe exhaust.

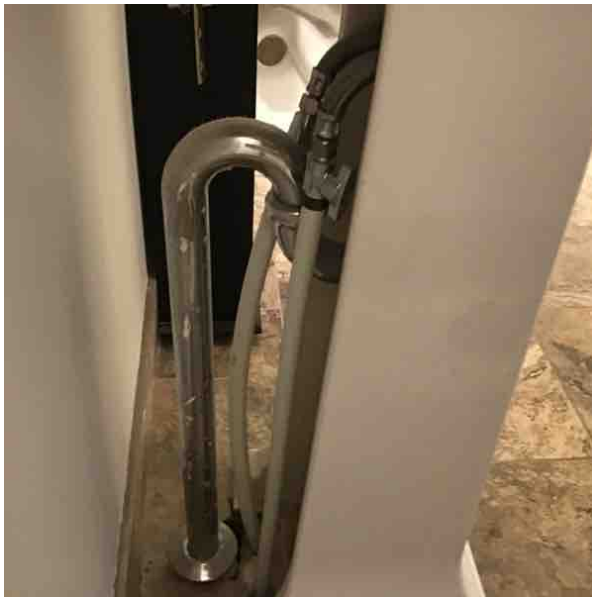
9.3.1 The trap configuration under some sinks is a non standard / improper installation (ie. S trap / no venting) but is commonly found in houses of this age. Recommend having a plumber assess to ensure proper drainage and prevent potential sewer gases from entering house.

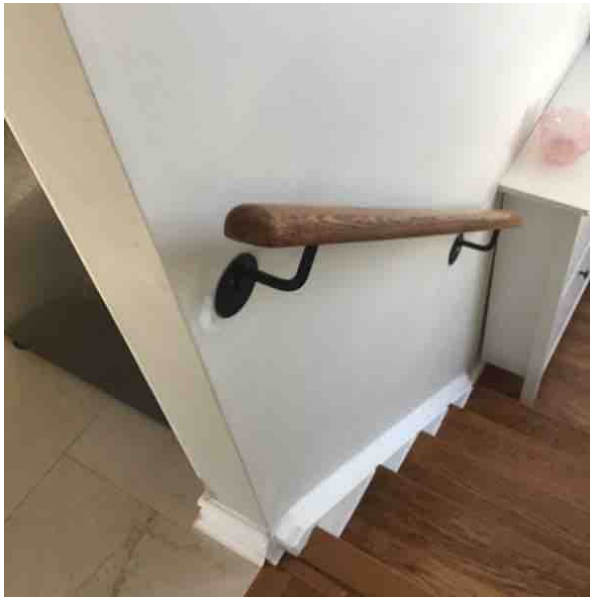
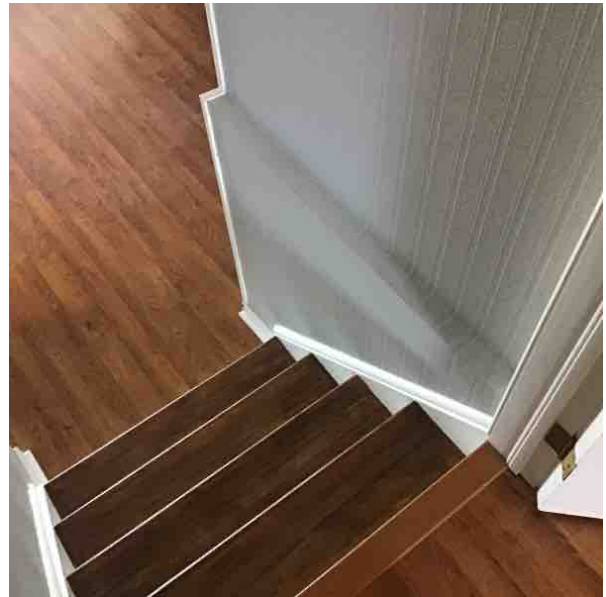
10.5.1 Advise caution as the handrails do not return into walls at the ends - consider improving the installation and install a handrail on steps to lower level for fall hazard prevention and safety.
