THURBER ENGINEERING LTD.

**7138 MARBLE HILL ROAD, CHILLIWACK, BC
GEOTECHNICAL REPORT**

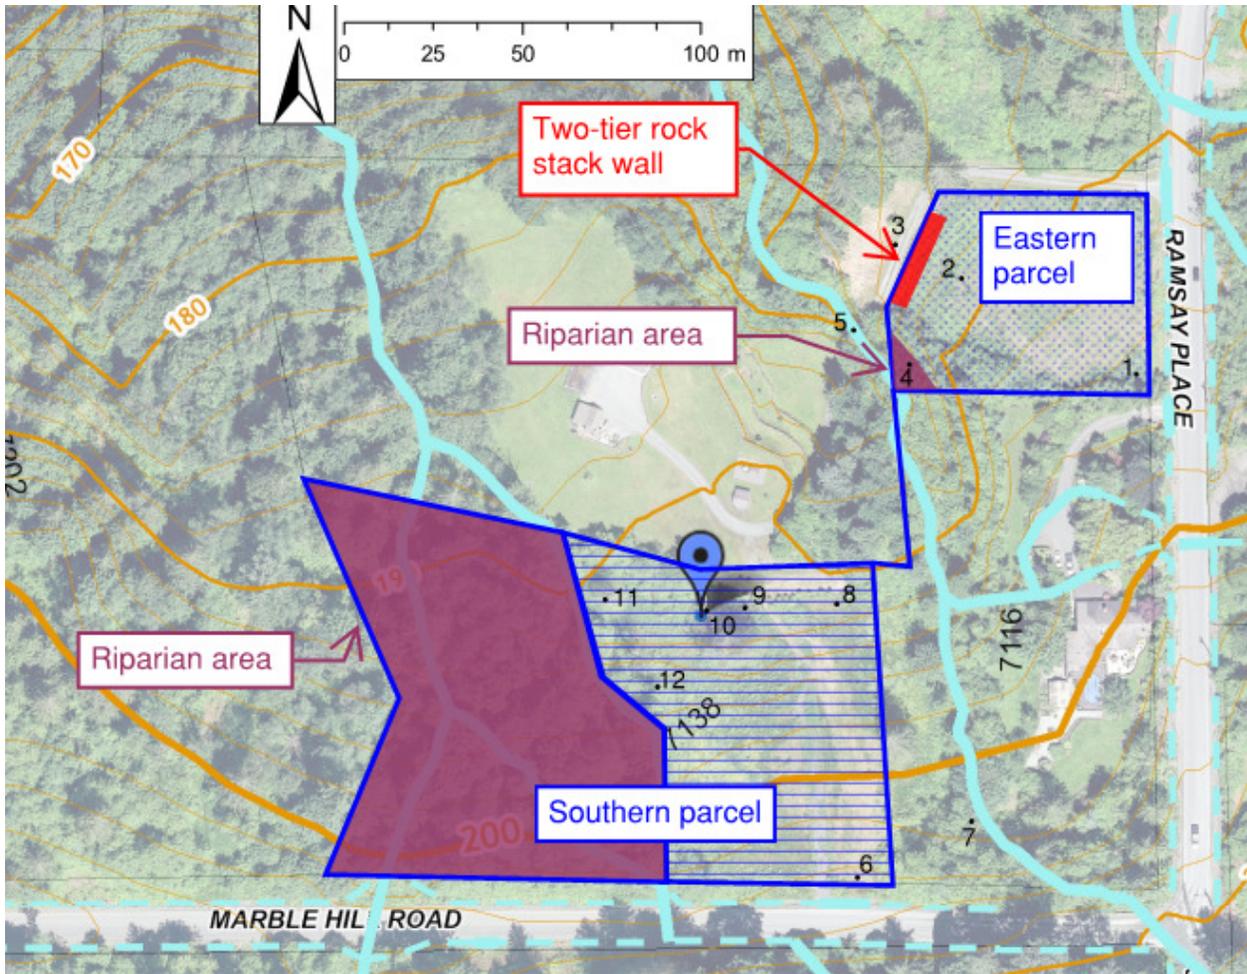
Figure 1 – Project area, including way points WP Nos. 1 to 12.

The property at 7138 Marble Hill Road in Chilliwack, BC is located on the Eastern Hillside. The property comprises two separate parcels: the southern parcel is adjacent to Marble Hill Road, whereas the eastern parcel is adjacent to Ramsay Place (see Figure 1). Freedom Construction obtained Preliminary Lot Approval (PLA) for subdivision of the eastern parcel into three lots, and rezoning of the southern parcel in a May 2, 2017 letter from the City of Chilliwack (City). We understand that the eastern portion of the southern parcel is proposed to be rezoned to Suburban Residential Zone and that the western portion of the southern parcel is proposed to be rezoned to Limited Use Reserve to preserve the undevelopable area in a natural state. This proposed division largely follows the unnamed tributary that runs approximately north-south through the southern parcel. Freedom Construction requested a geotechnical assessment of the property for subdivision approval, in accordance with the geotechnical requirements stated in the PLA letter from the City.

Paul Slangen, E.I.T. of Thurber conducted a site reconnaissance on July 6, 2017. The reconnaissance concentrated on the portions of the properties proposed for residential development, that is the eastern portion of the southern parcel and the eastern parcel (see Figure 1). Reconnaissance of the private properties directly uphill of the parcels was limited to visual observations from the road.

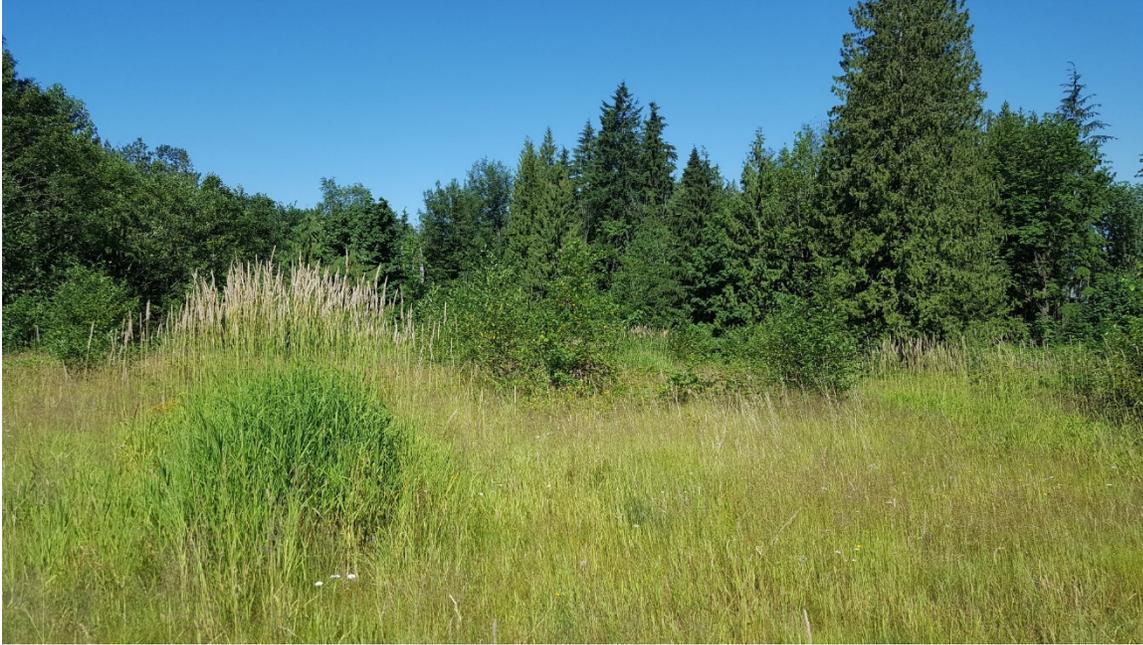
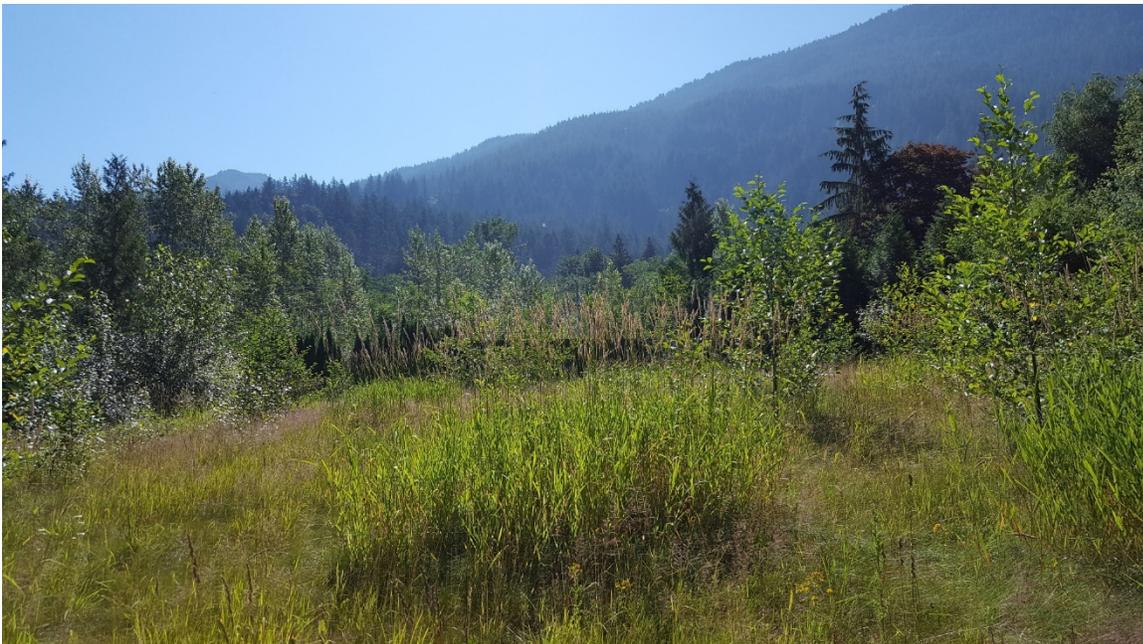
The eastern parcel slopes gently downward to the northwest at about 8° and is largely covered by grass, shrubs and some trees (see Figure 2 and 3). A rock stack wall comprising two tiers each about 0.7 m high and separated by a 3 m wide bench accommodates the grade difference between the gravel road and the western boundary of the parcel (see Figure 4). The southwestern corner of the parcel comprises a steep river bank down to Marble Hill Creek (see Figure 5). Curved tree trunks and seepage coming from the bank were observed at way point WP#4, indicating slow ground movements (i.e. soil creep). The area uphill from the eastern parcel, east of Ramsay Place comprises a few residential developments in a densely forested area; it was not traversed by foot.

Figure 2 – WP#1 looking west (10:12AM)

Figure 3 – WP#2 looking east (10:16AM)

Based on a review of historical data and our site reconnaissance, landslide activity on the subject property appears limited to local soil creep ground movements near the creek banks. We recommend that all permanent buildings are located beyond a setback line sloping 2H:1V from the toe of the creek banks. We further recommend a permanent building setback line of 2H:1V from the toe of the lower tier of the rock stack wall at the western boundary of the eastern parcel.

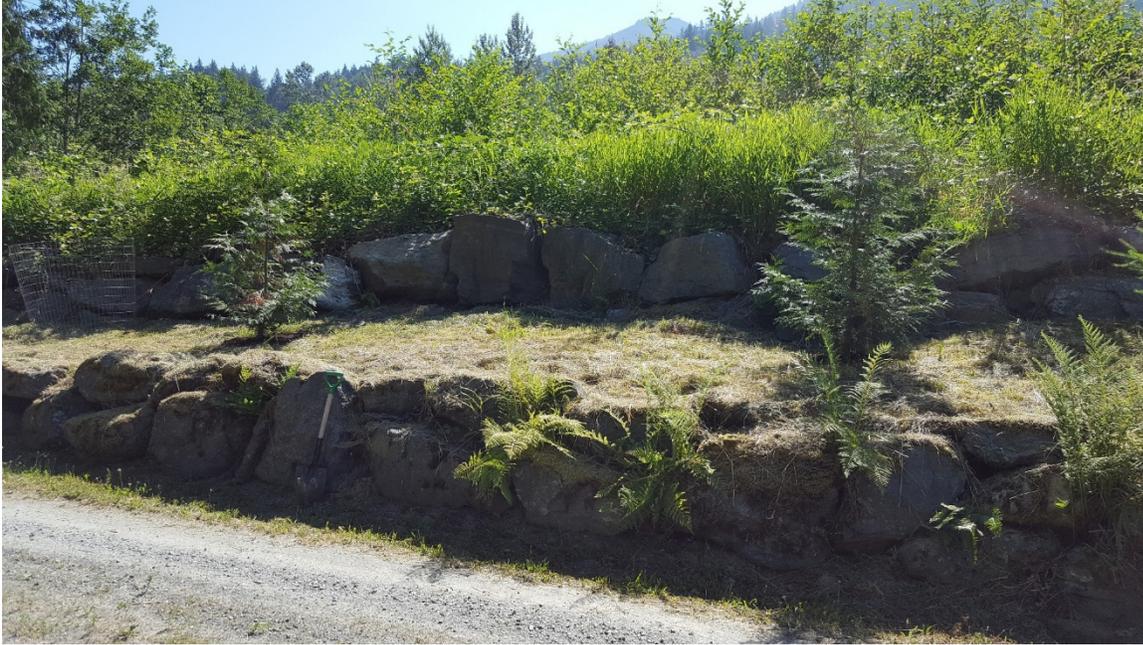
Figure 4 – WP#3 looking east-north-east (10:21AM)

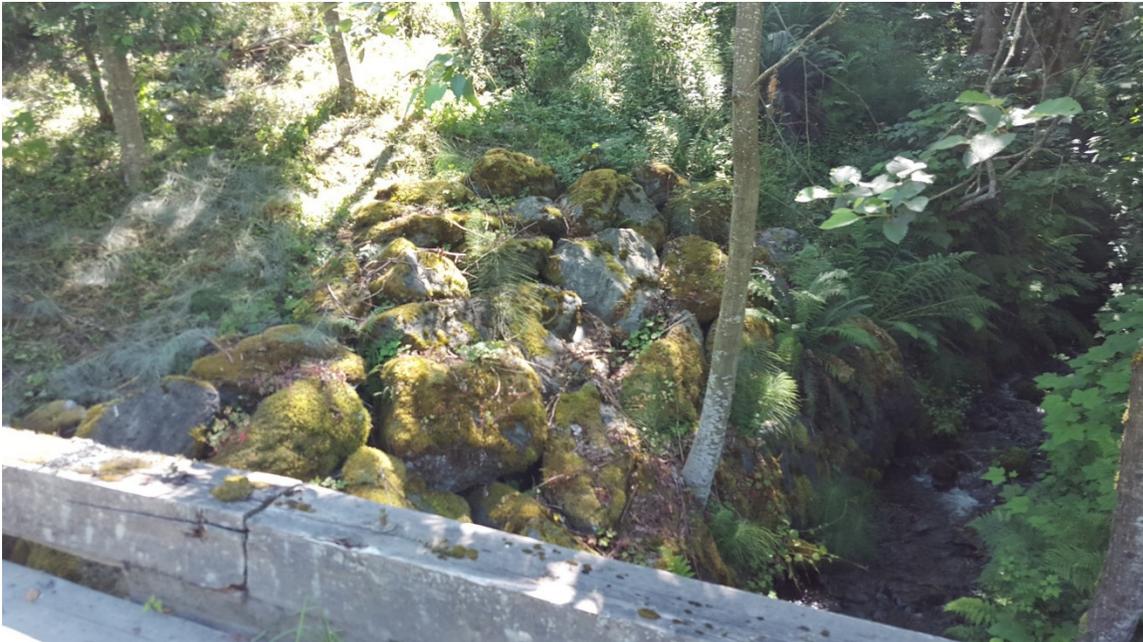
Figure 5 – WP#5 looking east (10:35AM)

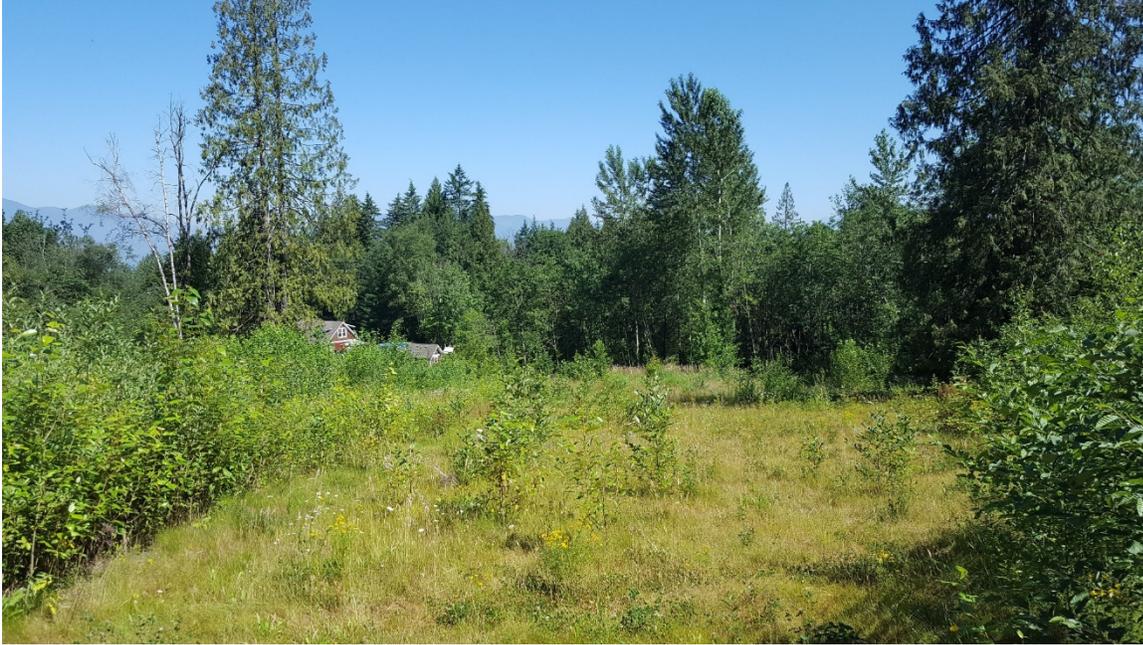
The eastern portion of the southern parcel slopes gently downward to the north at about 9° and is largely covered by grass, shrubs and trees (see Figure 6). Groundwater seepage was observed at several locations on the ground surface in the slightly steeper northern portion of the site at WP#9 and WP#10. The densely forested western portion of the southern parcel (see Figure 7) comprises a riparian area, which was not traversed due to bear sightings.

Figure 6 – WP#6 looking north (10:54AM)

In general, the portions of the eastern and southern parcels that do not comprise riparian area appear suitable for residential development from a geotechnical engineering perspective. Considering the observed seepage from the terrain and in the test holes, basements are not recommended with the current site grades. Comments regarding specific geotechnical engineering issues required to be addressed for DP Areas 2 and 6 are discussed in the following sections.

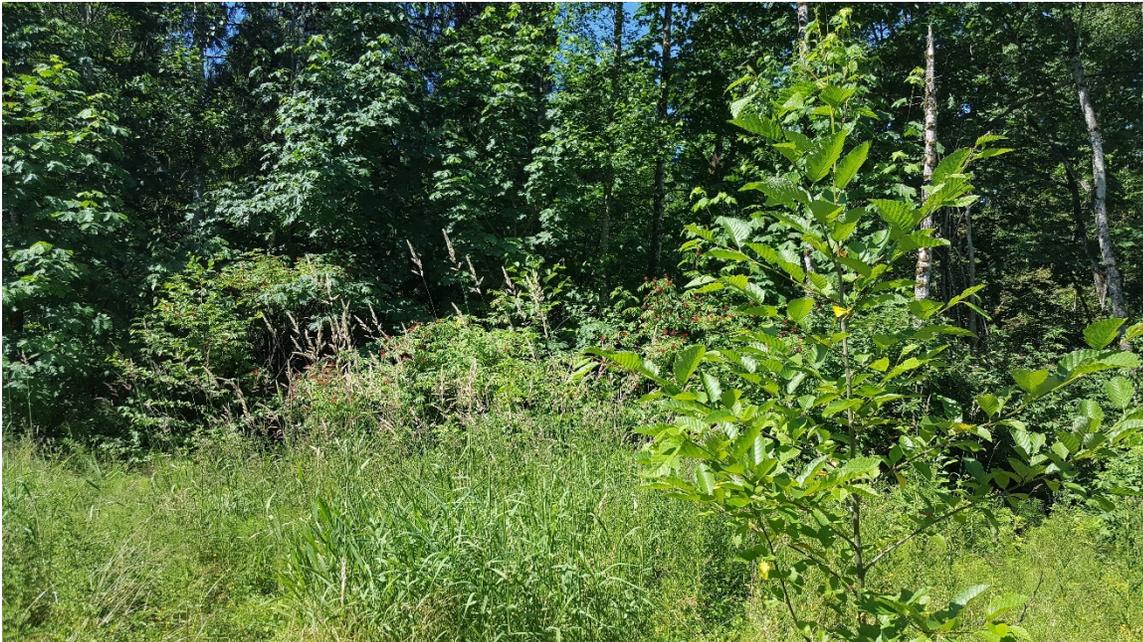
Figure 7 – WP#12 looking west (11:14AM)
