## Home Inspection Report

PROPERTY INSPECTED:  
**78 Branstone Road**  
**Toronto, ON M6E 4E4**

**Date of Inspection: 02/24/2025**

Inspection No. 914902-819

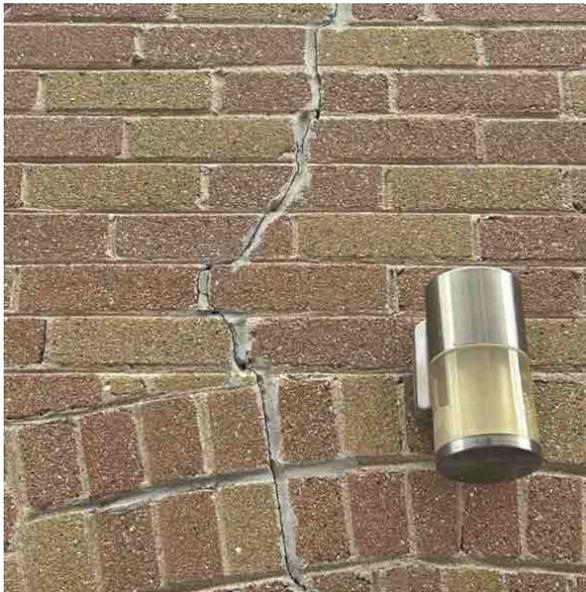
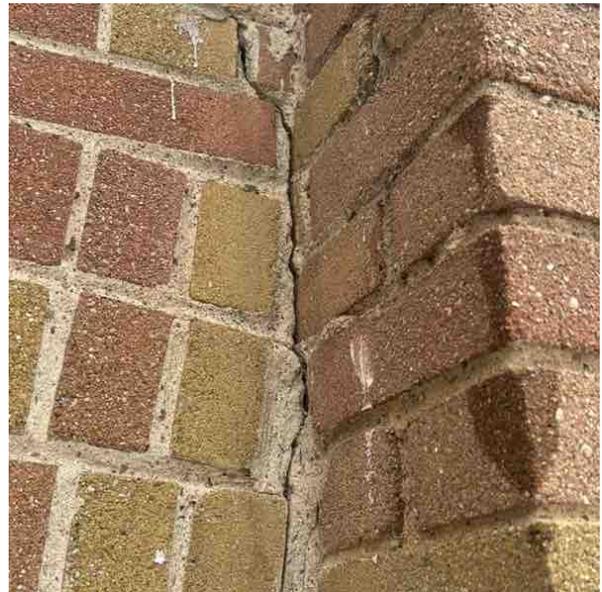
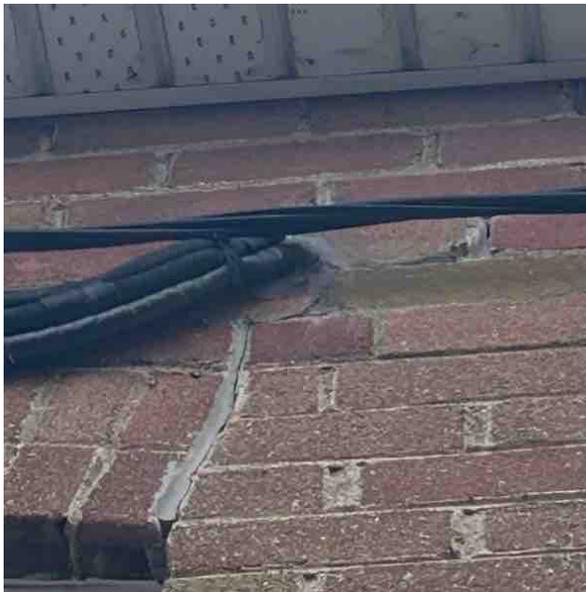
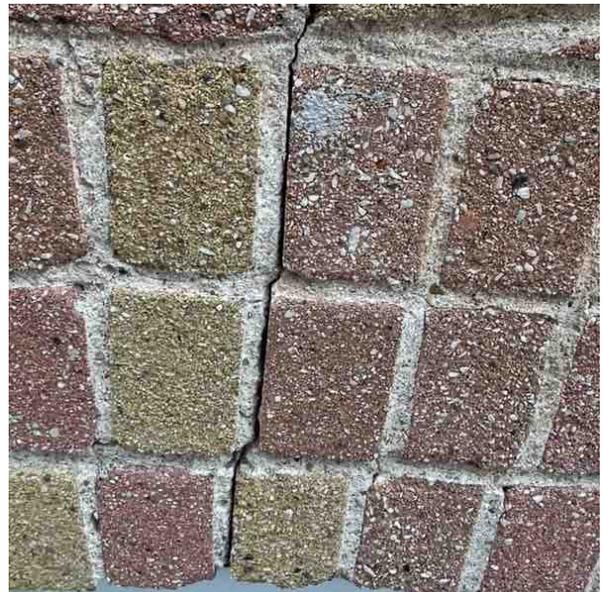
2.2.1 Previous repointing repairs noted where step cracking present. As part of ongoing maintenance repoint any deteriorating mortar joints, seal all cracks / gaps / holes (consistent with age of house) and caulk / seal around wall protrusions (ie vents) to prevent potential water penetration and further deterioration.

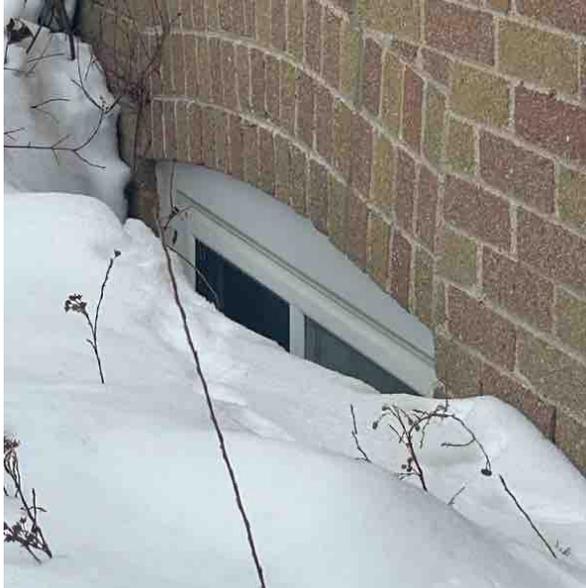
2.7.1 Consider installing window wells and covers (domes) over window wells for all at grade windows to divert snow and water away from basement windows to help prevent water penetration and subsequent damage to interior finishes.

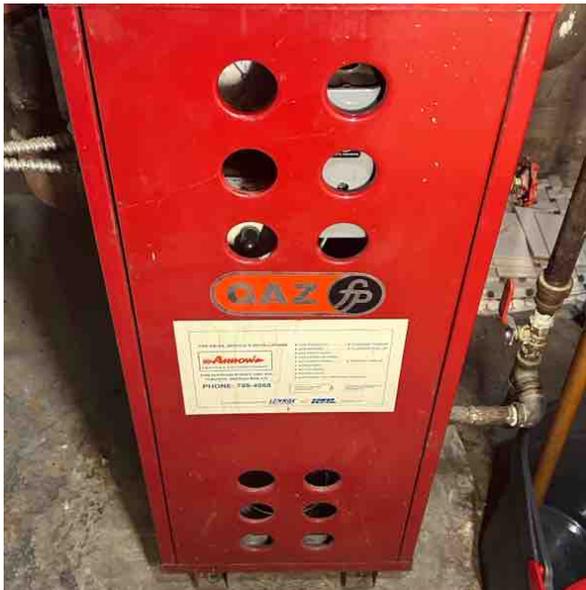
7.5.1 The boiler is at the end of its typical life expectancy (25 + yrs old) - the remaining useful life is unpredictable! Replace the system when it fails, when repairs are no longer cost effective, or pro-actively to prevent loss of functionality. Recommend having the entire system serviced when taking possession and then annually thereafter as this may prolong the longevity of system.
