## Home Inspection Report

**683 West Shore Boulevard  
Pickering, ON L1W 3G2**

**Date of Inspection: 02/17/2025**

Inspection No. 914902-816

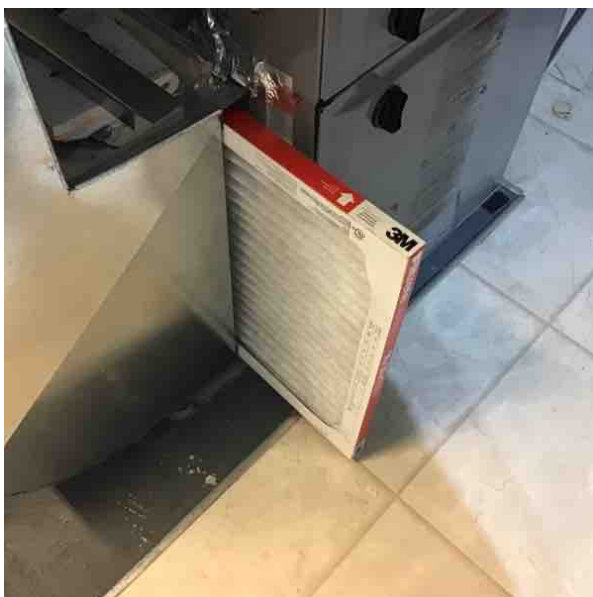
8.6.1 Remember to clean or replace the air filters every three months or as required to encourage proper operation of furnace / ac unit.

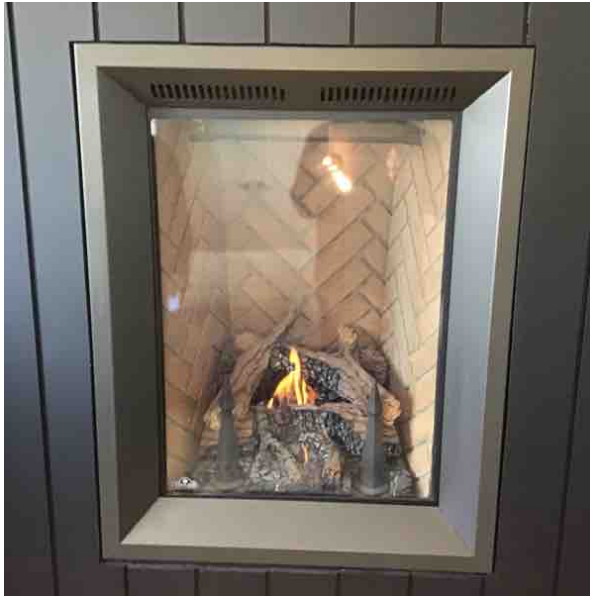
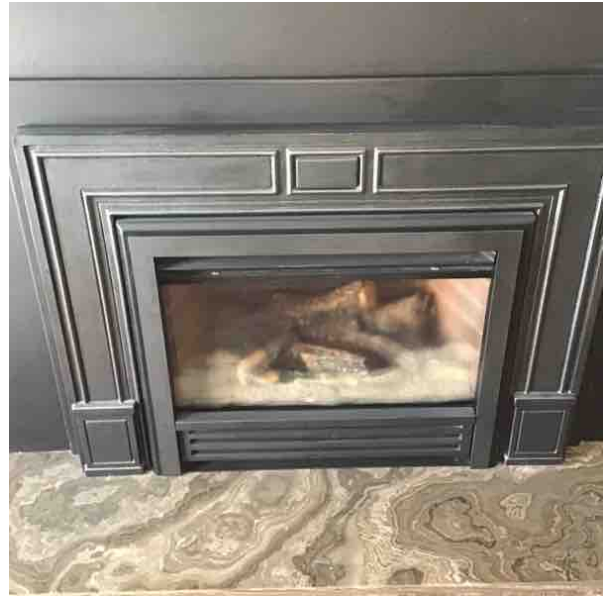
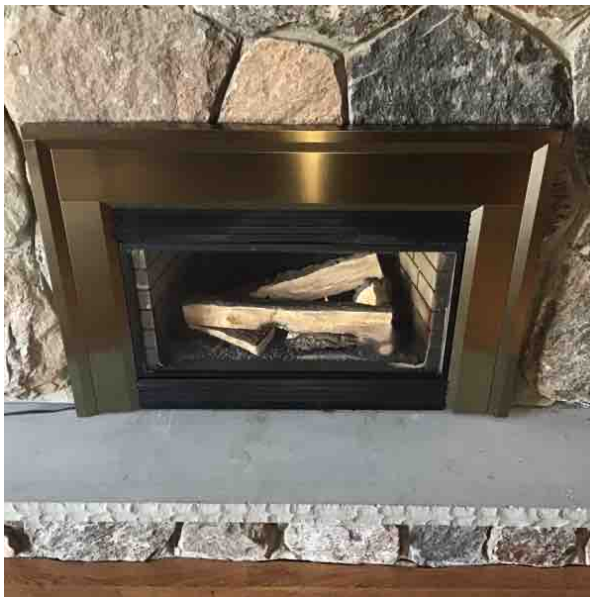
11.1.1 The gas fireplaces were operated and functioned as intended. Annual servicing by a fireplace specialist is recommended to evaluate the functionality and safety of the entire system.
